## **Chilliwack Outdoor Club Trail Maintenance 2023 Report**

**by Jim Alkins**

## Trail Maintenance Activities

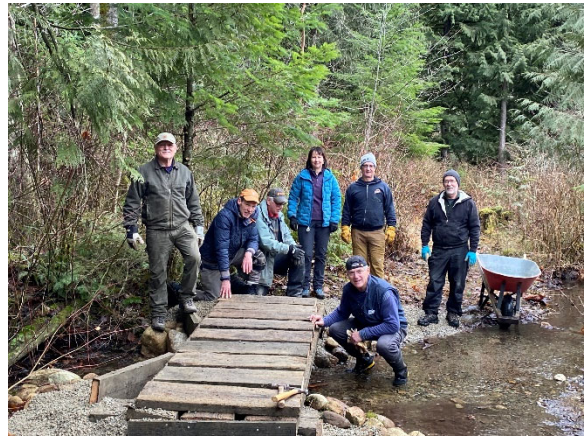
### Bridge East of Emil Anderson Group Pit:

In January, eight members of the club participated in the one-day bridge construction project on the TCT west of Emil Anderson Group (EAG) pit in the Chilliwack River Valley. EAG repurposed timbers located at the pit were used for the bridge. The project was a bit of a training exercise to confirm the tools and connectors required and the suitability of the repurposed material.

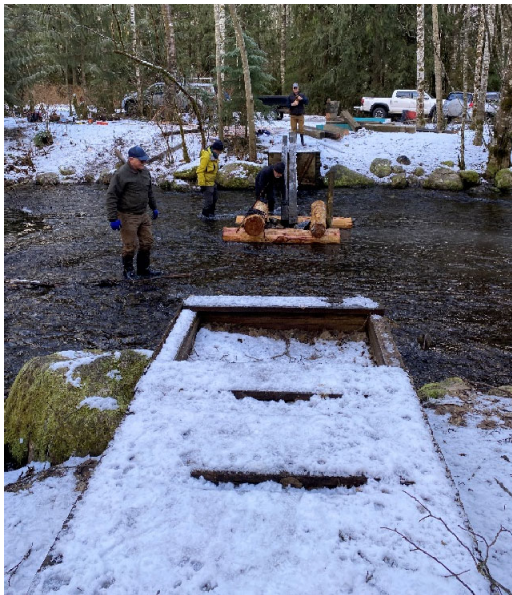
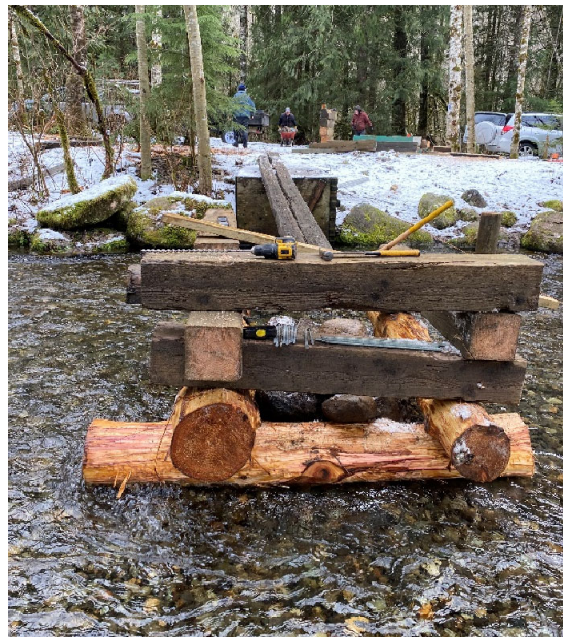
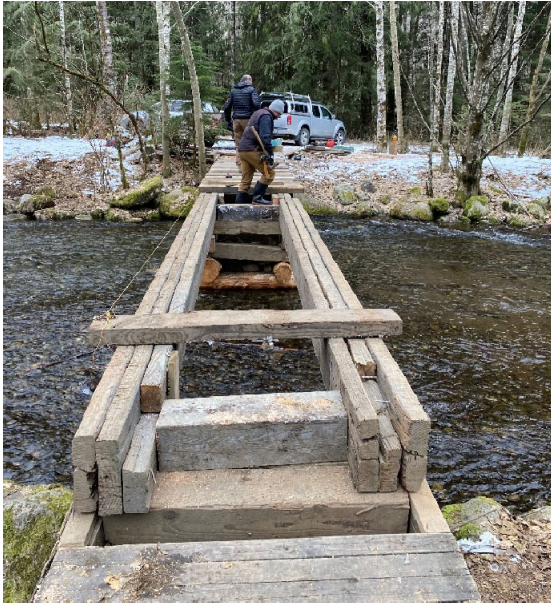
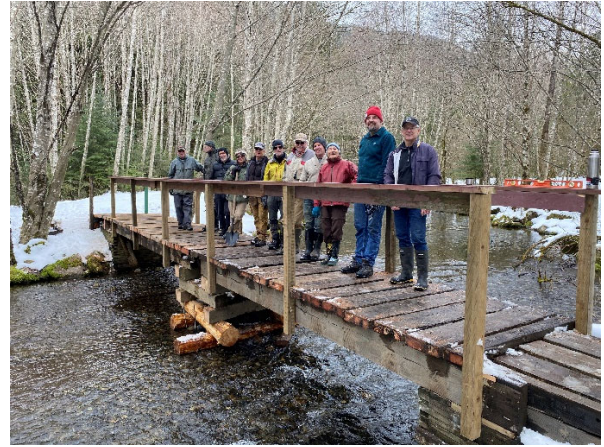
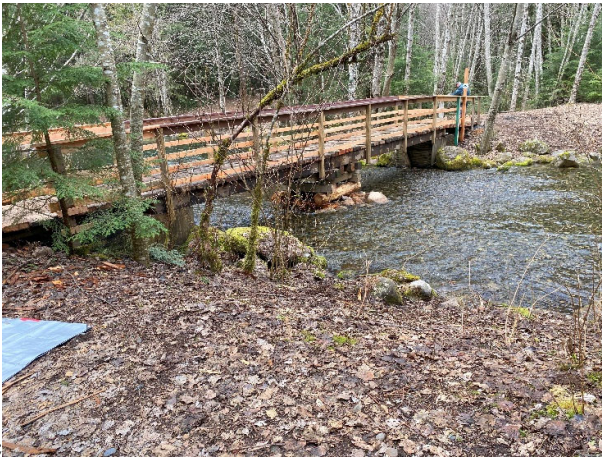
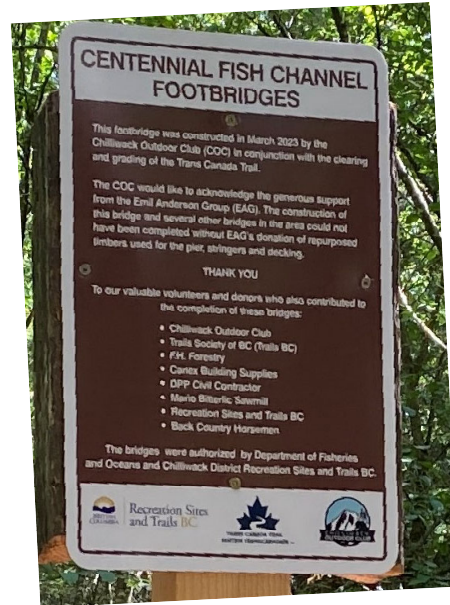
### Construction of Pier and Bridge 1km East of Riverside Campground

The 1995 bridge across the spawning channel was failing so a new pier and two span bridge was constructed with approval of DFO in a new location. The repurposed timbers from Emil Anderson Group were used and the construction was completed in February and March. Cedar logs from Wayne Furnass were used for the base of the pier and 10 inch timbers were fastened above them to achieve the required height. Boulders were added to hold the pier in place. Due to the winter conditions the water level was low which allowed easy access for the pier construction. The frozen ground prevented the completion of end ramps and railings which were complete in April and June. Signage was added at three bridge sites to recognize the donors and volunteers.

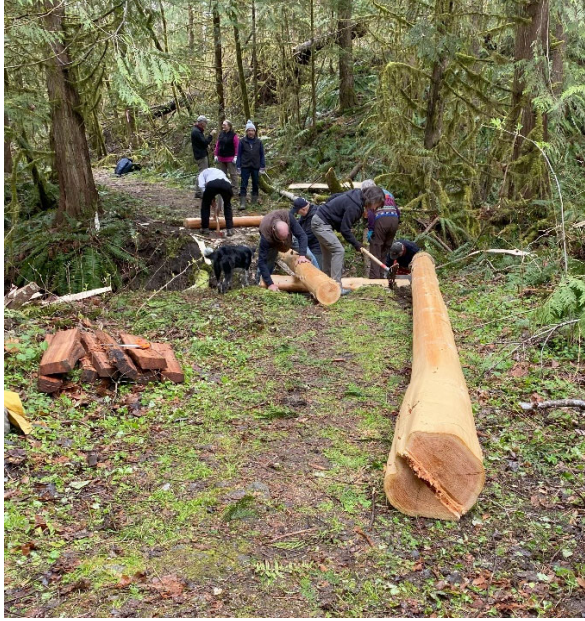
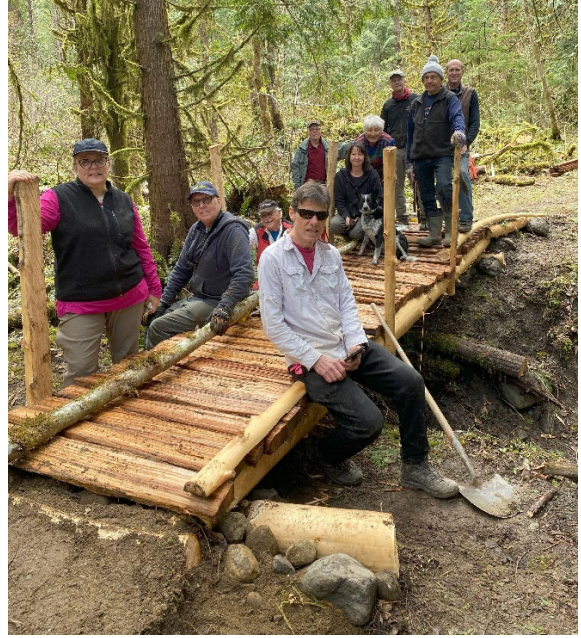
### Replacement Bridge on Tolmie Section

An old bridge over a narrow stream bed collapsed so the deteriorated material was removed and a new cedar bridge was constructed across the gap. A cedar tree was used for the abutment seats and stringers and seasoned wood from an old growth log was split to create the decking.

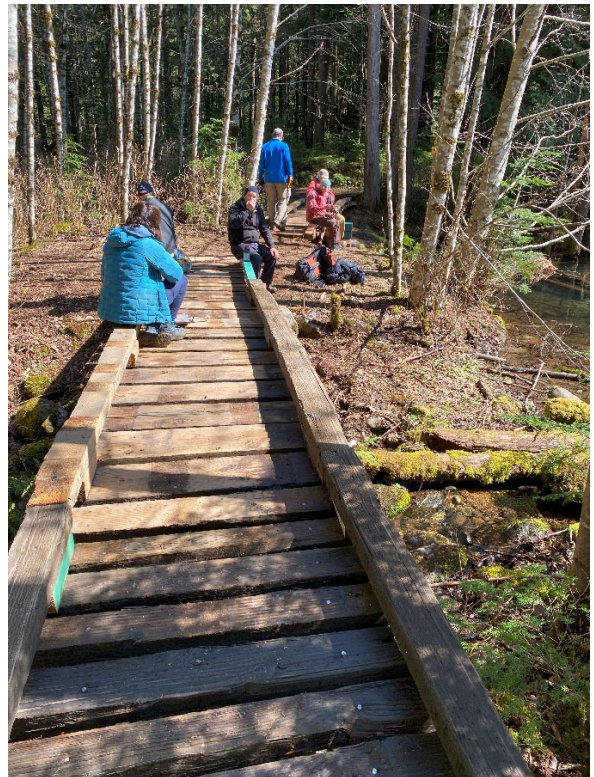
**Two new bridges at Angel Wing Fish Channel**  
Using the repurposed material from Emil Anderson Group two new bridges and approaches were constructed across the outlets from the spawning pond as shown below. Both bridges were over 35 feet long including the approaches.

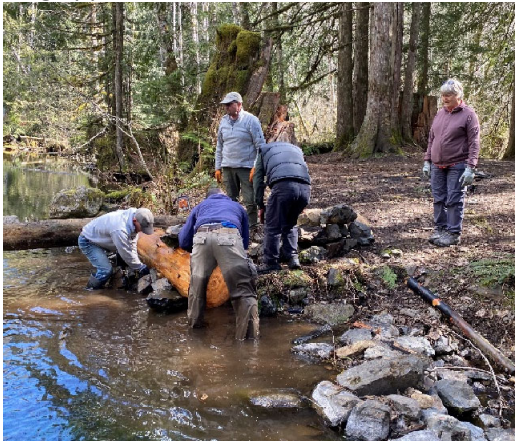
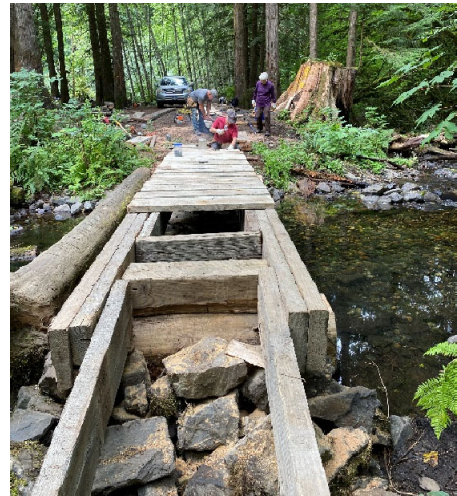
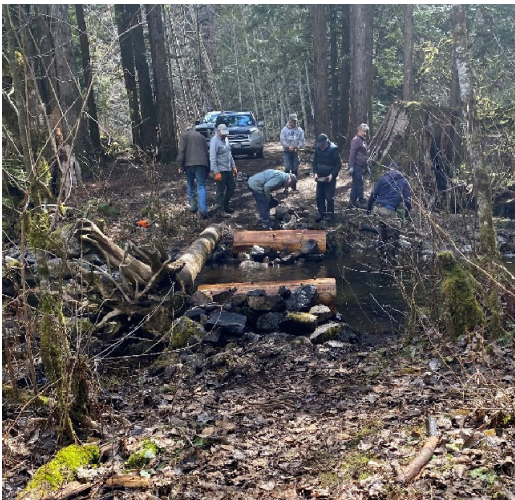
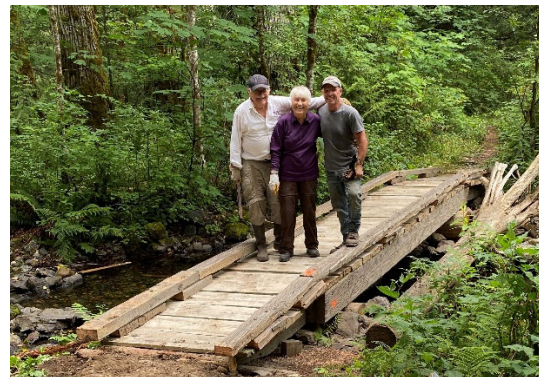
### Replacement Bridge East of Riverside Campground

The old bridge across the spawning channel had failed and was washed down stream. DFO approved the construction of a replacement bridge. Abutment seats were cut from a large cedar blowdown and repurposed timbers from Emil Anderson Group were used to construct the 18 foot bridge and 10 foot long approaches.

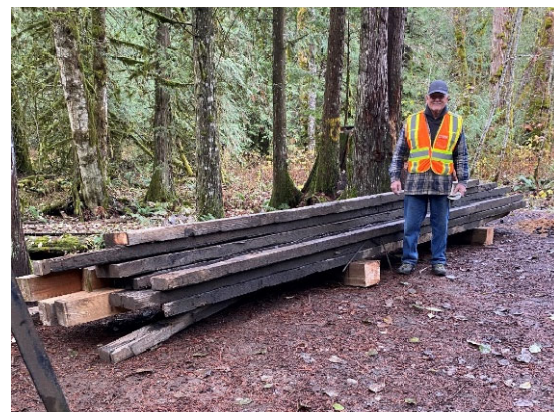
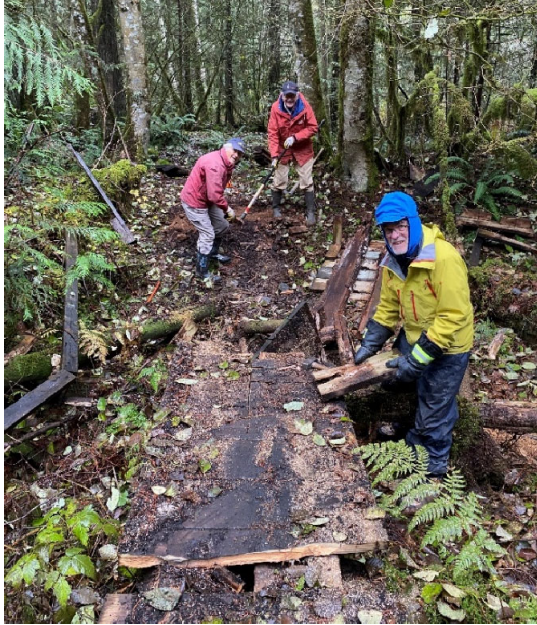
### Replacement of the 100 foot Boardwalk East of Riverside Campground:

The replacement was carried out using repurposed material from Emil Anderson. The replacement was completed in sections starting with the far bank approach which had deteriorated to an unsafe condition. On November 15, the original material was removed from the first 20ft section to allow construction of new piers and placement of the stringers, decking and curbs.

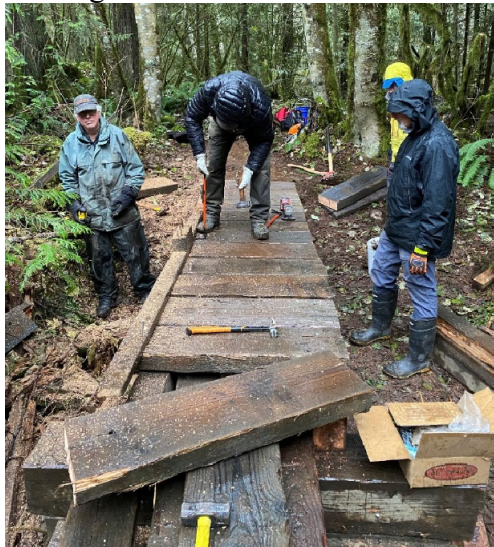
The curbs were added and the edge of the decking were trimmed.

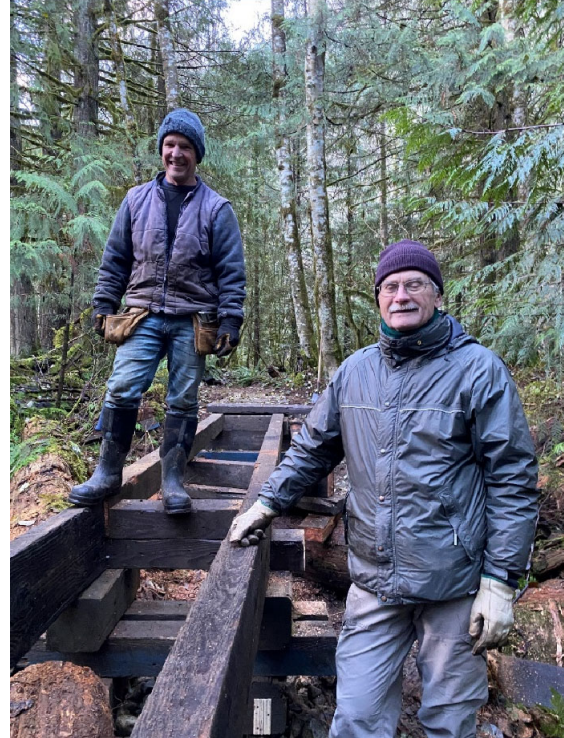
On November 23 the crew replaced another section of the bridge. New piers were constructed using the 6"x6" timbers and the large stringers. The stringers and blocking were attached using M15 rebar.

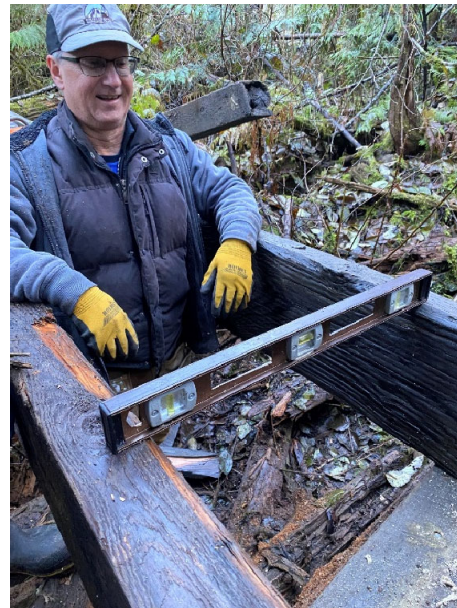
The level of the stringers was confirmed.

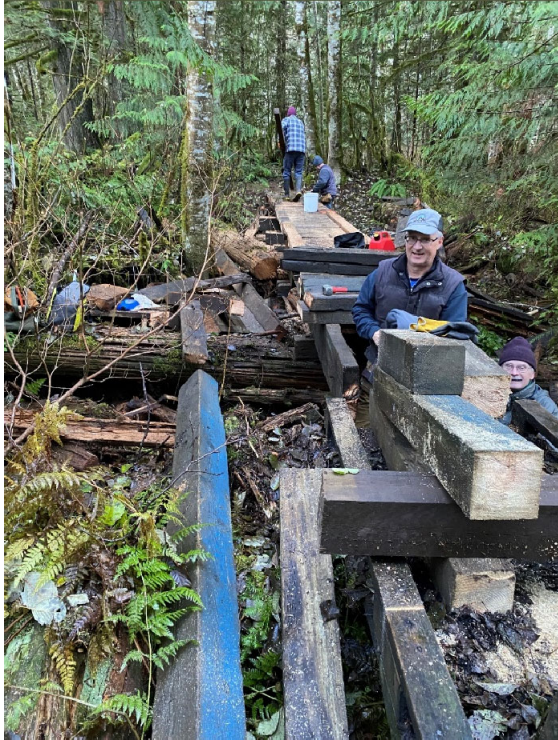
As the next section was constructed, the decking was cut and secured to the stringers, Final blocking and stringers were secured across the 8 ft deep gap and the new curbs were added.

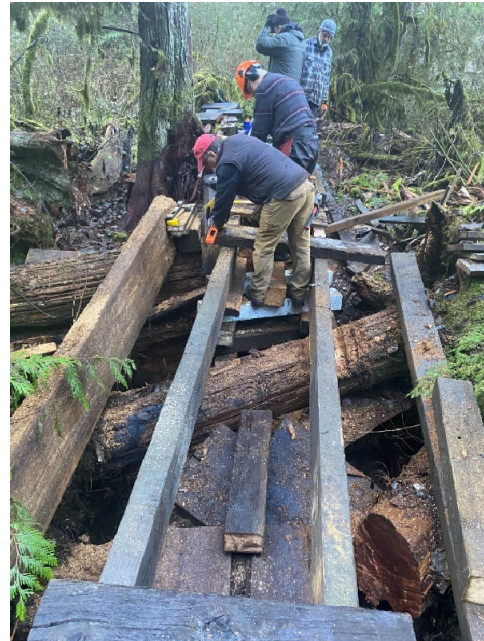
task of aligning the piers and the stringers very challenging.

The process was repeated by removing the deteriorated deck and constructing new timber piers; the old cedar deadfall made the

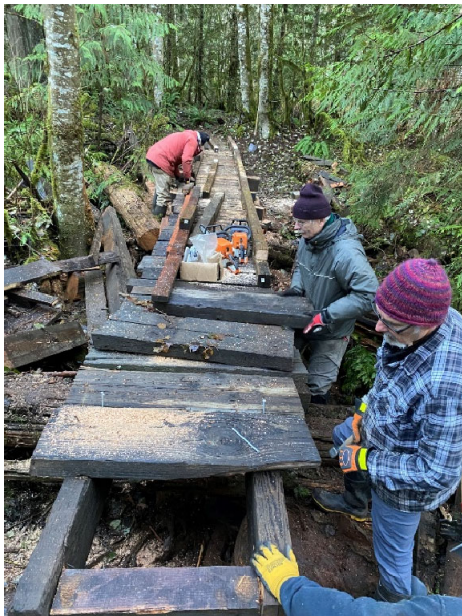
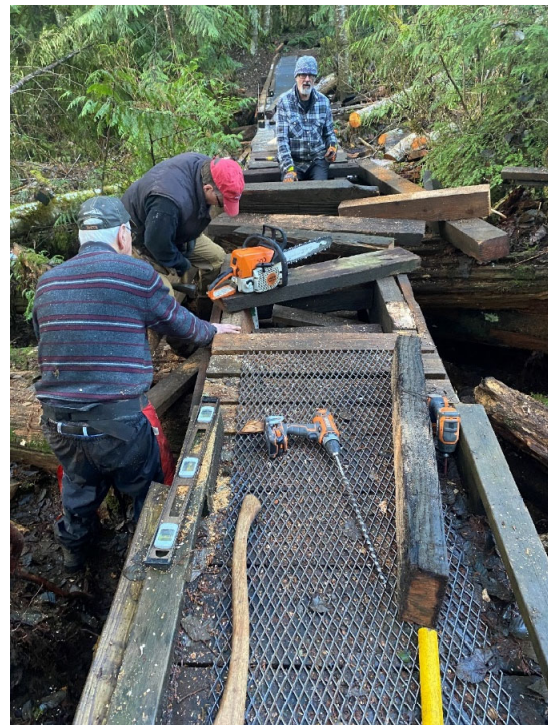
Next the decking was secured to the stringers with 6 inch spikes donated by Canex and the curbs were attached along the completed deck.

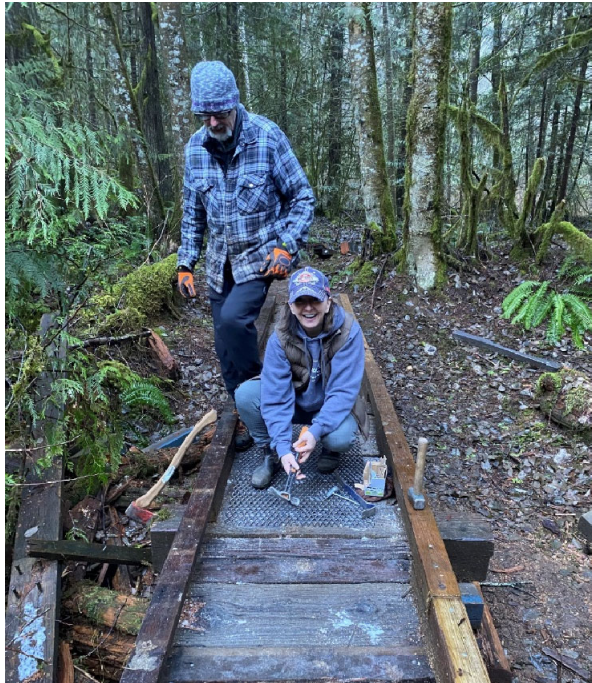
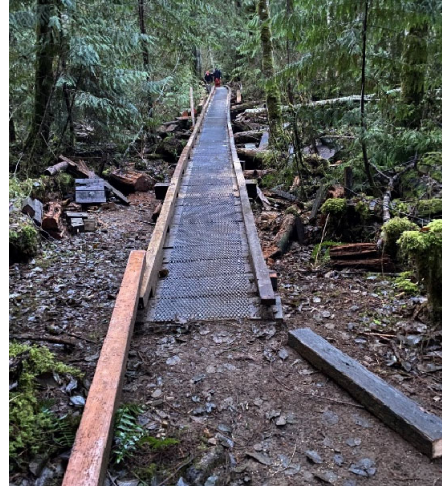
The ice and leaves were removed from the deck so the expanded metal mesh provided by the Back Country Horsemen Society

could be applied. The metal mesh certainly reduced the slip hazard.

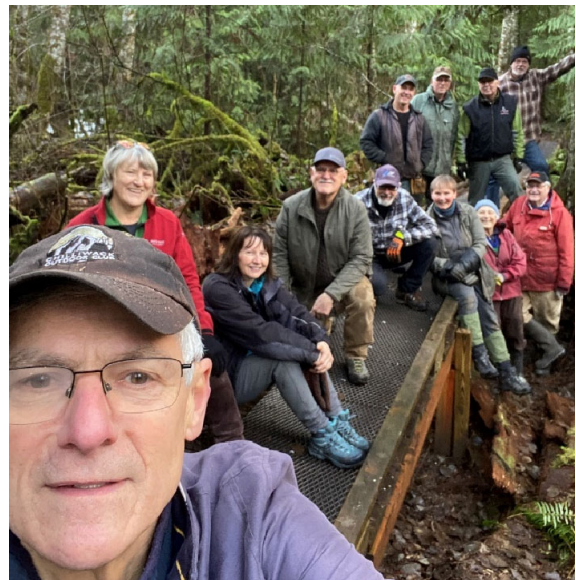
The finished 100 foot long boardwalk/bridge with the curbs and expanded metal mesh with the happy crew that worked on various sections of the project.

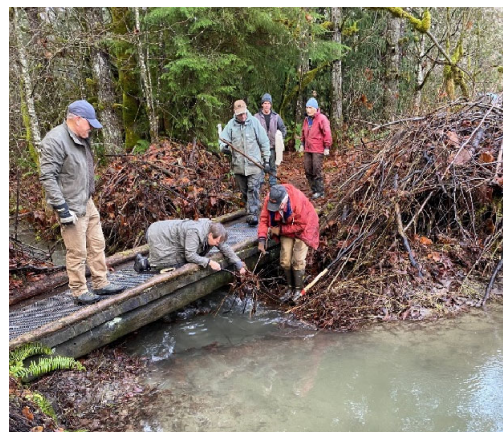
On December 15 the crew returned to add the expanded metal mesh to 5 bridges in the Thurston Meadows section of the Trail. At one bridge a beaver dam had to be removed by hand and grubbing tools.

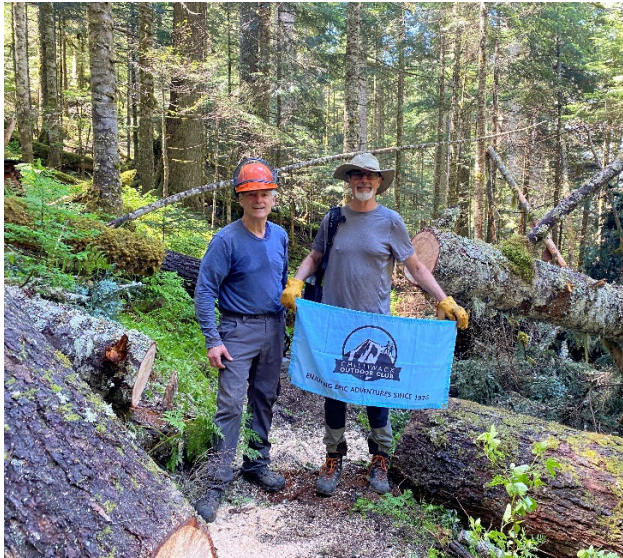
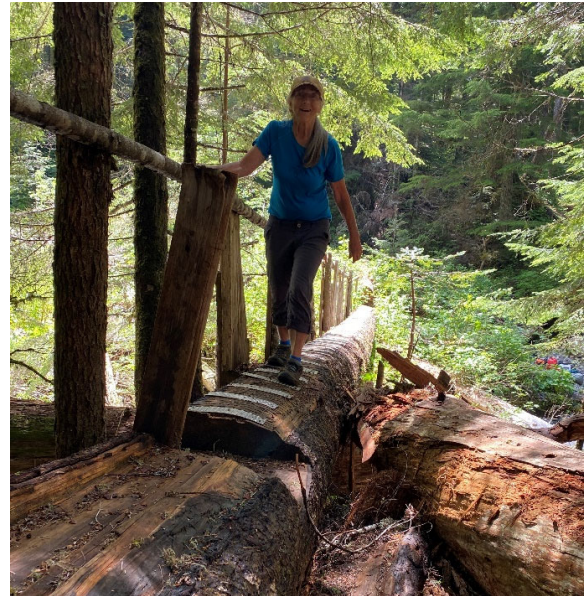
**Pierce Lake Trail:** The focus was the annual trimming of the soft vegetation to improve the sightlines around the parking area on Chilliwack Lake Road, and cleaning of the pit toilet. Numerous blowdowns were cleared from the trail up to the log bridge including the approach to the bridge.

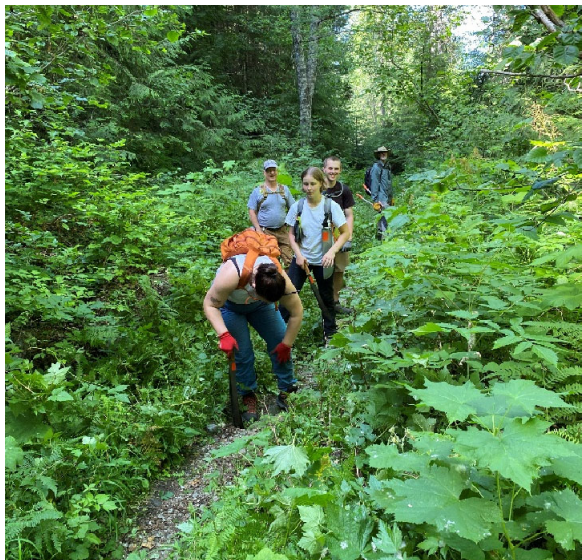
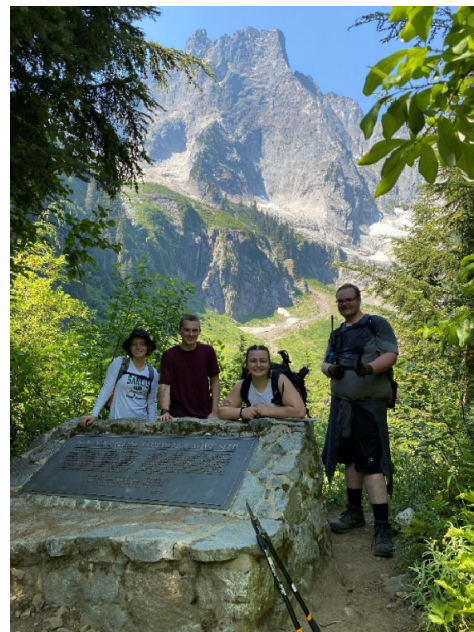
**Mount Slesse Memorial Trail:** The trail was cleared from the parking area to the propeller. The student summer crew, under COC supervision, spent two days on the trail using machetes and loppers. Power tools could not be used because of the fire risk. The COC members also continued the clearing of alders with loppers and handsaws on several hikes to the propeller.

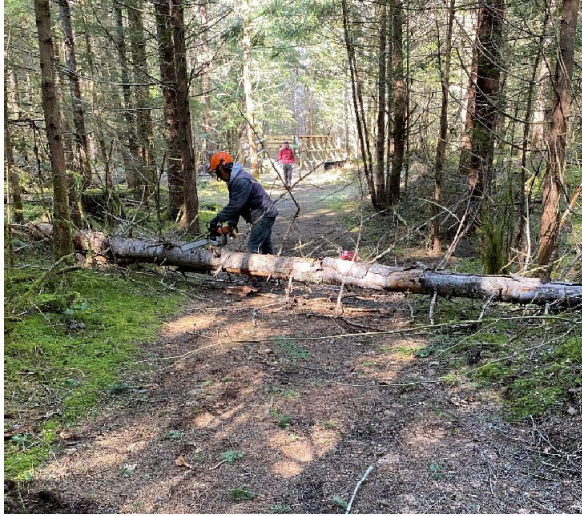
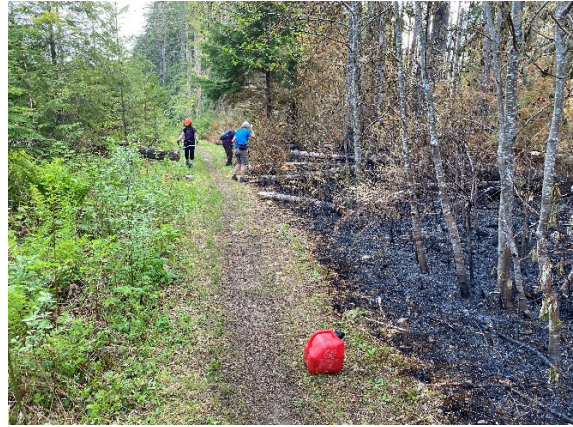
**The Trans Canada Trail:**

Club members worked with volunteers from Trails BC on the TCT to remove deadfall and clear alder brush from Liumchen Creek to Chilliwack Lake. The trail performed as an effective fire break when a wild fire due to a cigarette from a passing car broke out near the Pierce Lake trailhead.

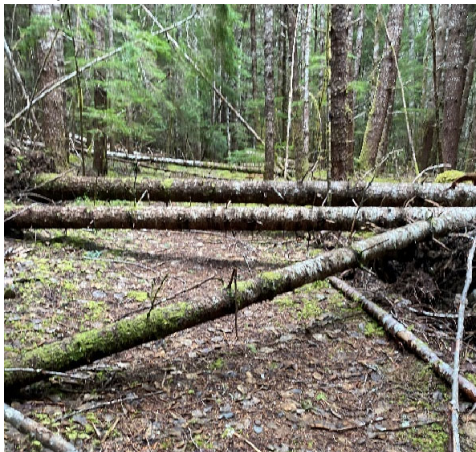
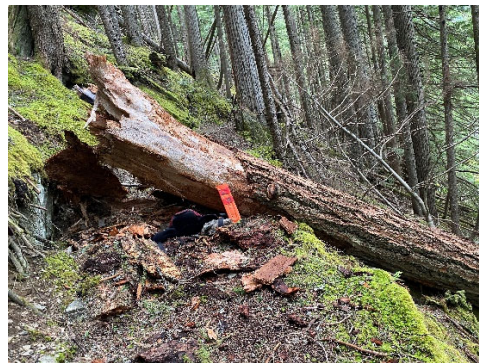
Silver Skagit Road was closed to the public all year due to flood damage. The contractor completing the road repairs allowed the COC crews access for trail maintenance. Deadfall and alder brush clearing were completed on the Hicks Section.

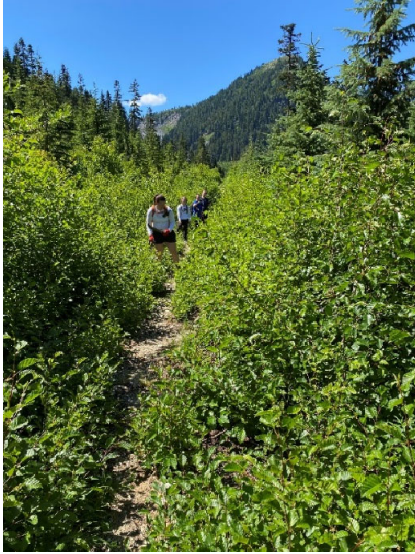
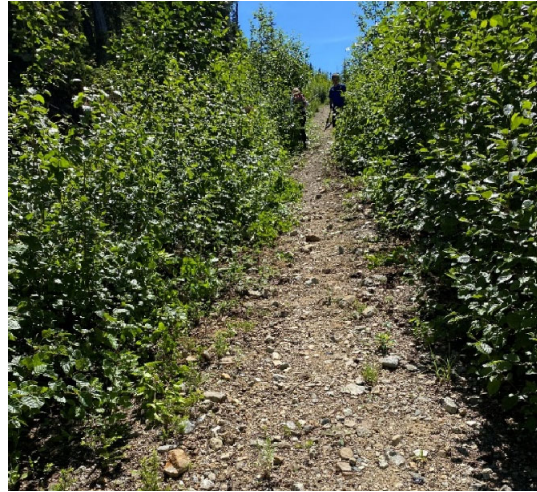
Due to the higher elevation and snow, Paleface Pass section of the trail was scheduled in late June and could only be partially cleared. Clearing and trimming were completed along the first 5km from Silver Skagit Road. In addition, similar work was completed for 4 km from the Chilliwack Lake end of the Paleface Pass section. Due to the high fire risk and an active fire in the area, power trimmers were not used so progress was slow and access to the middle 4km section was not possible. The summer student crew spent a day on the Chilliwack Lake side. Photos below show before and after clearing alder.

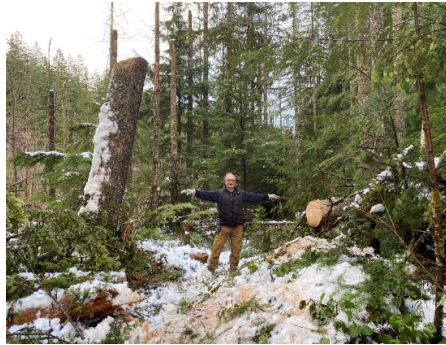
In addition, COC members cleared blowdown along the TCT in the Chilliwack River area periodically throughout the year as issues were identified.

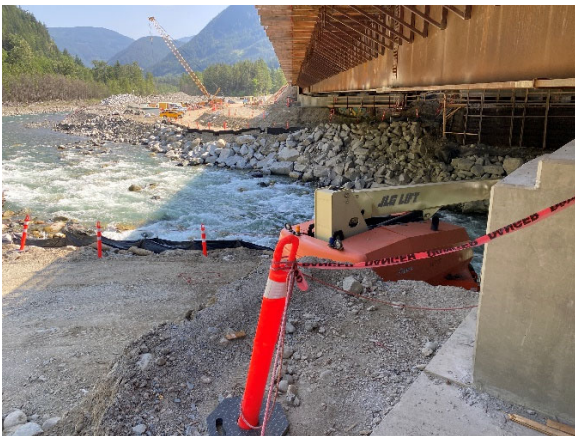
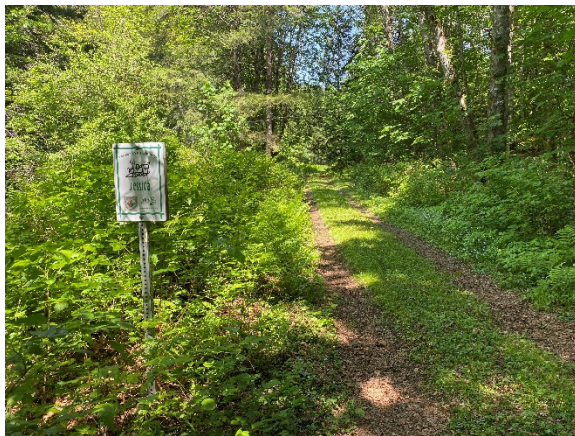
The Club also worked with Trails BC members to clear deadfall and repair erosion on the Sowaqua, Jessica, and Shylock sections of the TCT where access was possible. Future work will be required to develop the trail access under Hwy 5 at Sowaqua bridge which was under construction.
